Gillpatch™ Cargo Liner Repair Systems

Gillpatch III

Gillpatch™ III – With Rivets Cargo Liner Repair System
For the Repair of Overhead Cargo Compartment Liner Panels in Airbus Aircraft

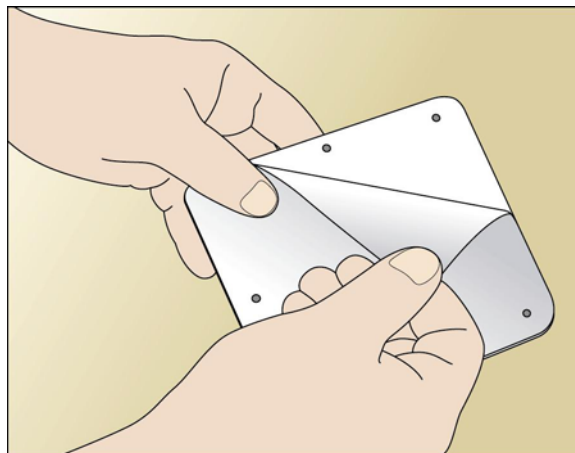
- 4.2 Carefully remove the release paper from the back of the repair patch to expose the pressure sensitive adhesive; this adhesive is very aggressive, and will hold the patch in place for use as the template for drilling holes in the liner panel. Be careful not to touch the adhesive or allow dust or dirt to settle on the adhesive once it is exposed. See Figure 2.

Figure 2 - Peeling Release Paper Backing

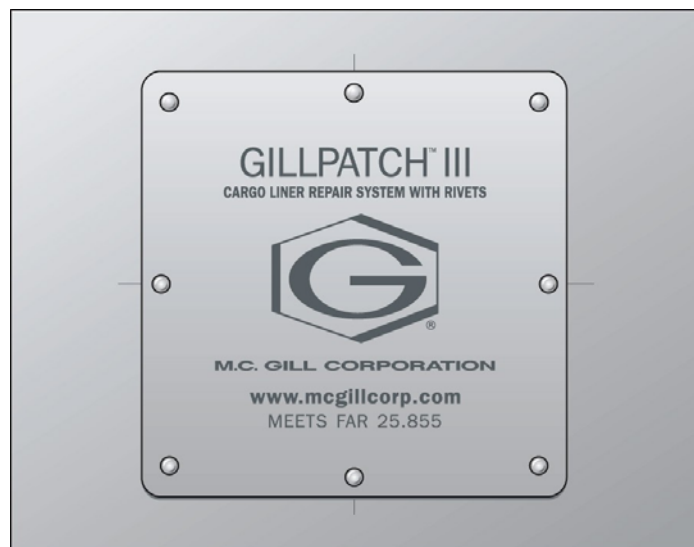
- 4.8 The finished repair patch installation is shown in Figure 8.

Figure 8 – Installed Gillpatch III with Rivets
